Western Forest Products Hazard Alert

Site: Englewood Forest Operation

Incident : **Line Saw Near Miss - Cut-off disc failure**

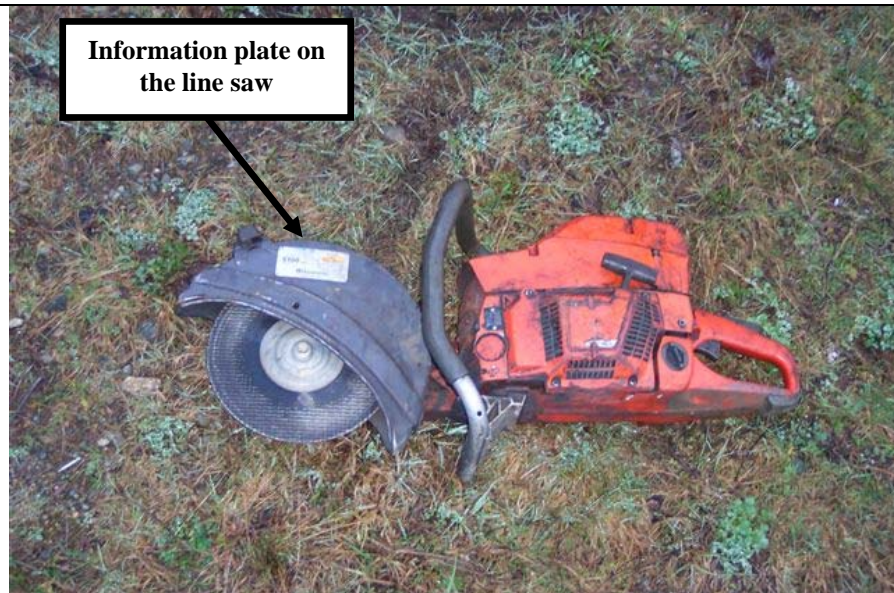
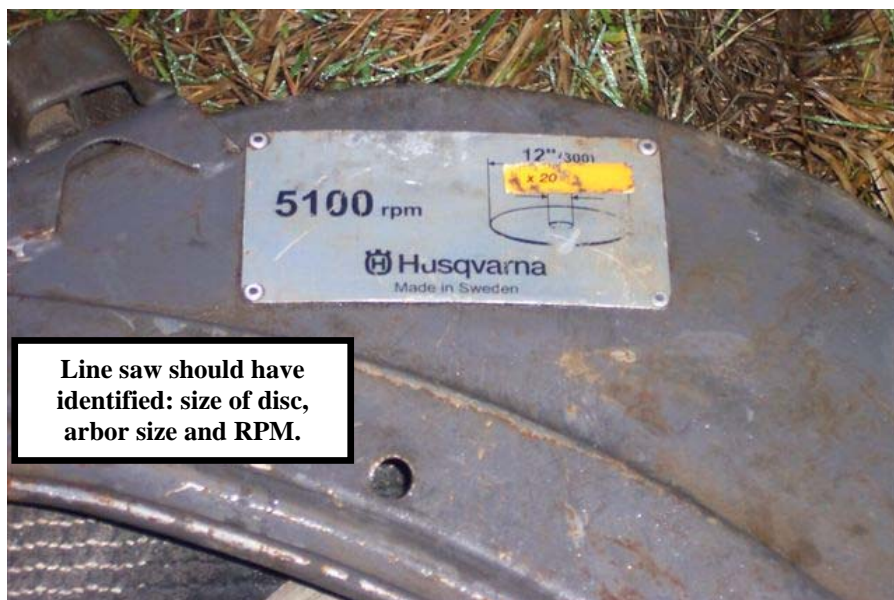
After further investigation, the cut-off disc was found to be incorrect for the size of the line saw arbor. The arbor is a mounting step on the saw head that pilots the cut-off disc to ensure it is centered when installed. The disc is then attached using a bolt and washer plate.

This particular line saw's arbor required a disc with 20mm (~3/4") slot and a disc with a 25mm (1") slot was being used, which allowed it to rotate off-center and fail.

Line saw should have identified: size of disc, arbor size and RPM.

1. Ensure all crew members using a line saw are aware of the different size arbors and the importance to have the correct cut-off disc.
2. Check line saws within the Operation to determine if there are saws with different size arbors. Ensure they are identified appropriately.
3. Crew members must be aware of the need to always stop and check the saw if there is excessive vibration.
