SAFETY NOTICE

DIVISION: Mackenzie Wood Products Division
DEPARTMENT: Site II Sawmill
INJURY: Crushing
TIME OF ACCIDENT: Between 6:35 – 6:40 a.m.
TIME OF INVESTIGATION: Preliminary Report Nov. 22, 2006
TYPE OF ACCIDENT: Fatal

Canter Section (Side Heads) of the Quad-saw. The Quad-saw is a processing line which chips the edges of a log to produce a cant and then saws the cant into boards.

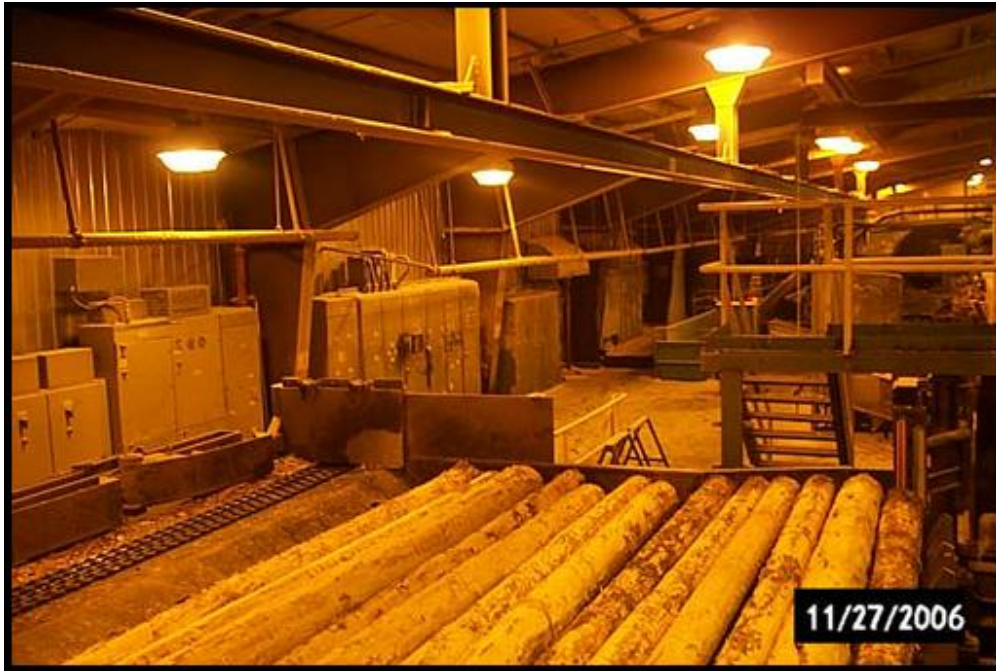
Photo 01 – Site II Quad West Side Location; Electrician View from Control Booth

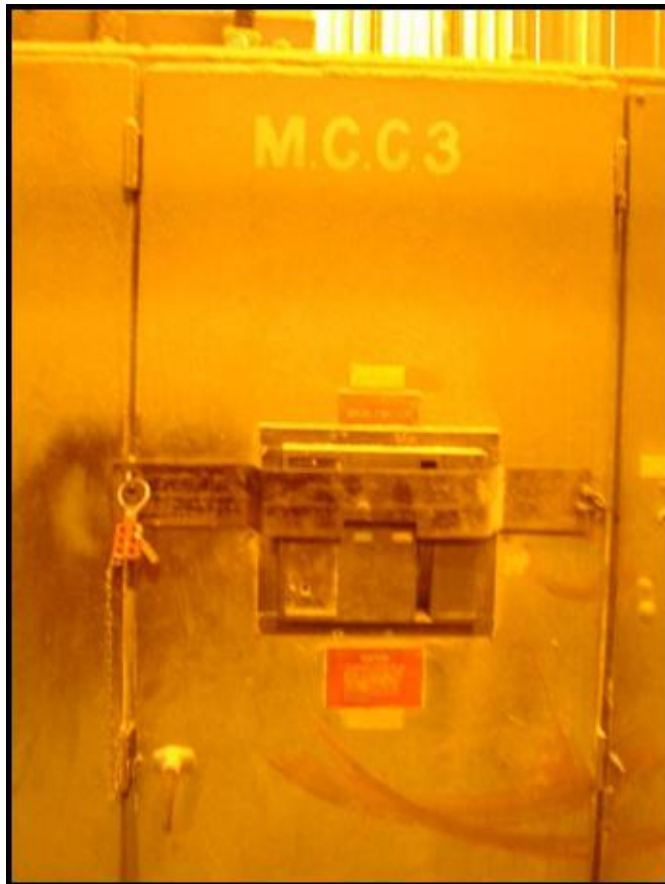
Photo 02 – Site II Quad West Side Location; MCC #3 Lockout Location Close-up view.

followed. The route he usually followed took him past the Motor Control Centre (MCC) where he would de-energize and lockout the Canter/Quad Saw/Band Saw. This lockout is engineered so that it only requires one lock, which the Quad-saw operator employee carried with him. The lockout also requires pinning the top head of the quad, so that if there is a hydraulic hose failure the head cannot lower from the force of gravity. Both the lockout and pinning the top head are performed from the west side of the Quad-saw.

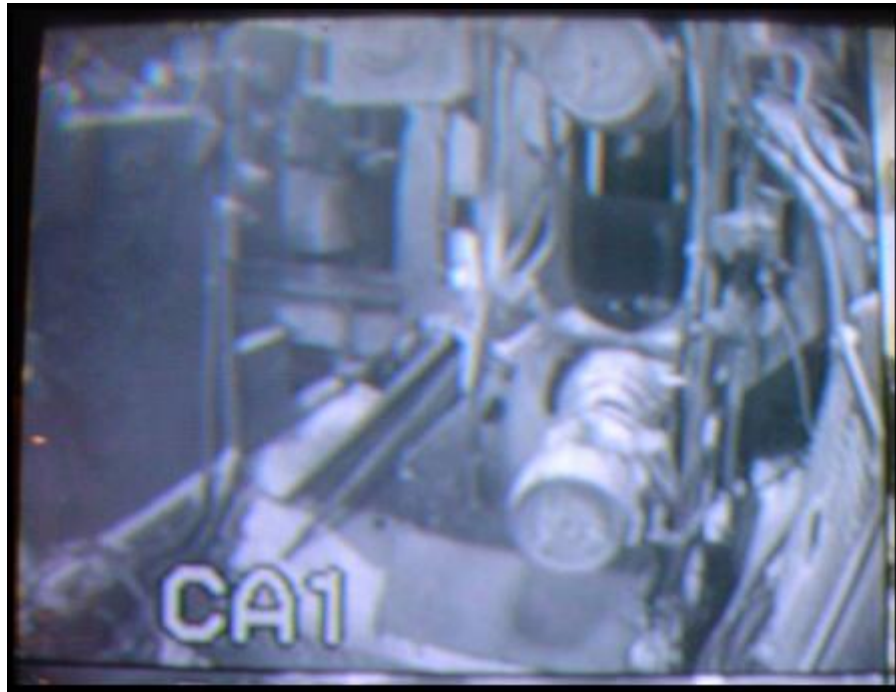
Photo 03 – Site II Quad CA1 Camera View of Chipping Side & Top Heads from the East Side Location

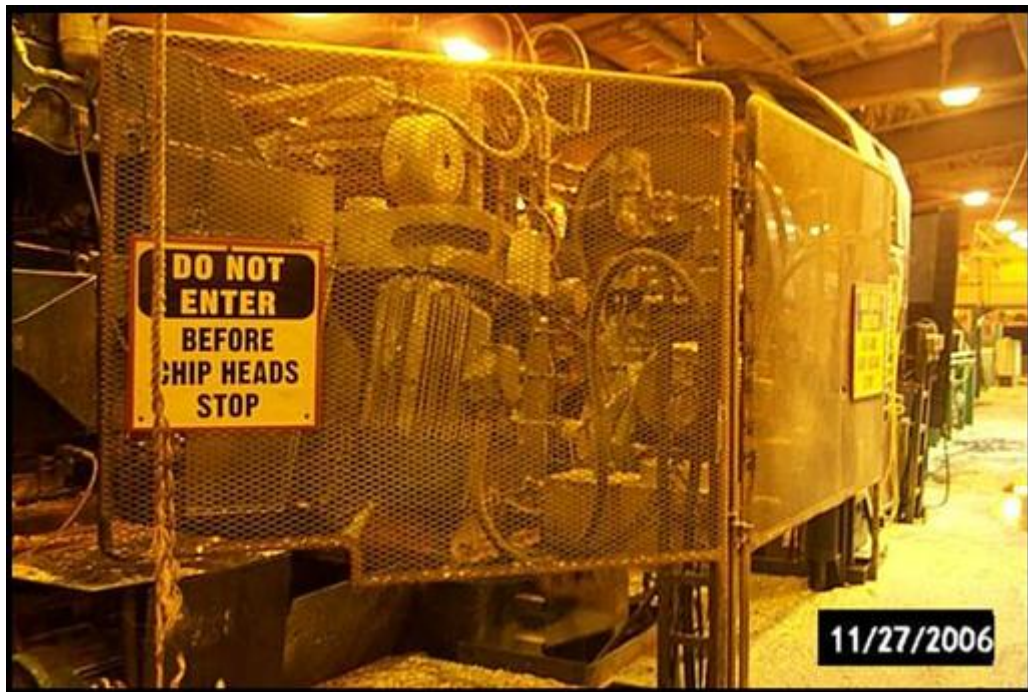
Photo 04 – Site II Quad East Side Location

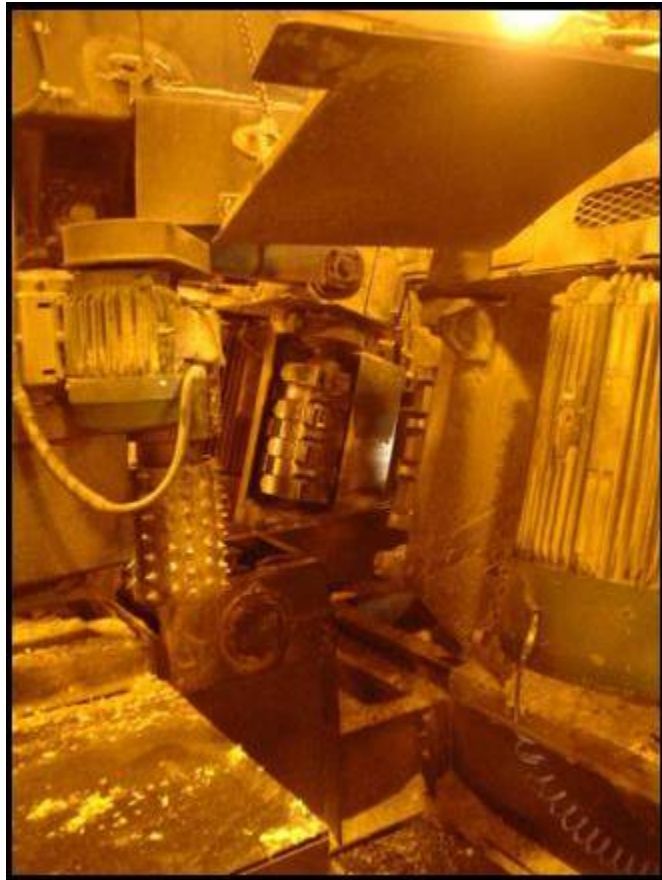
Photo 05 – Site II Quad East Side Location; View of the West Side Chipping Head and point of entry to change the Top Head Chipping Knives.

In this location he positioned himself between the side-heads of the Quad-saw, straddling the guide bar. With the Quad-saw turned off but the hydraulics energized, the side-heads are approximately 22 inches apart, and the top-head is approximately 24 inches high.

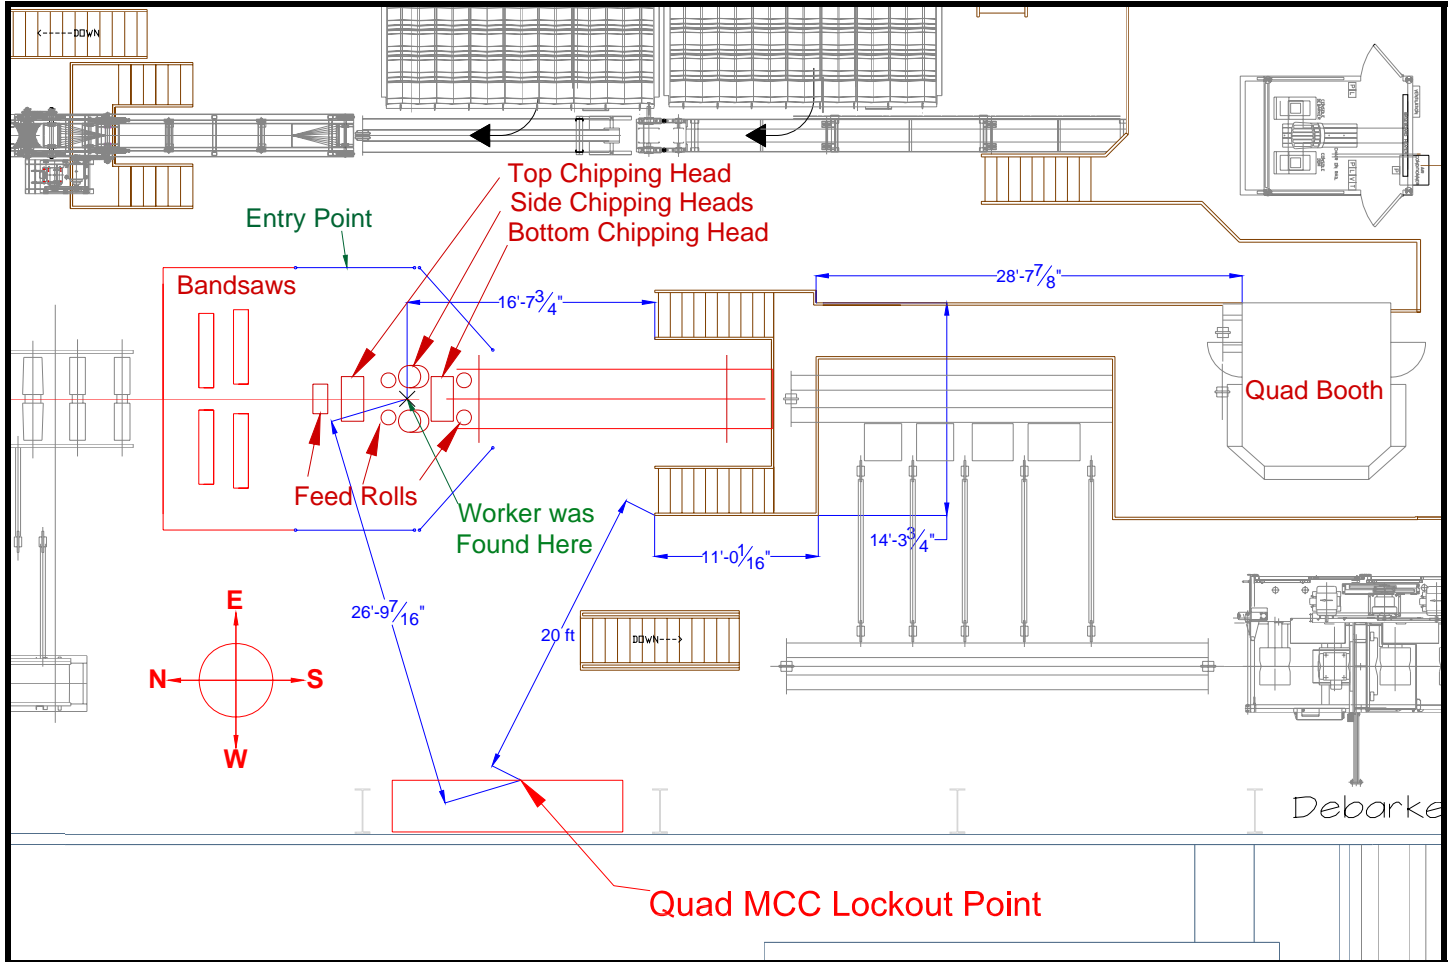
Location Drawing – Site II Quad Location

S2SM – Quad Area
